**PRELIMINARY ASSESSMENT/
VISUAL SITE INSPECTION**

**NATIONAL STARCH AND CHEMICAL COMPANY
MEREDOSIA, ILLINOIS
ILD 003 934 569**

FINAL REPORT

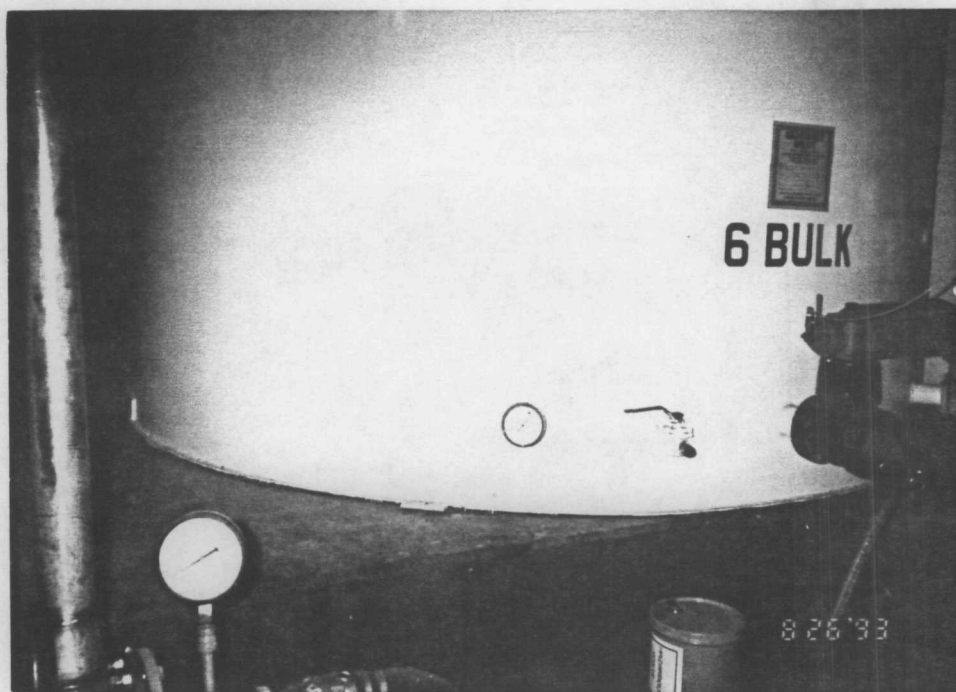
Photograph No. 1

Description: This photograph shows the Waste Polyacrylic Solution Storage Tank.

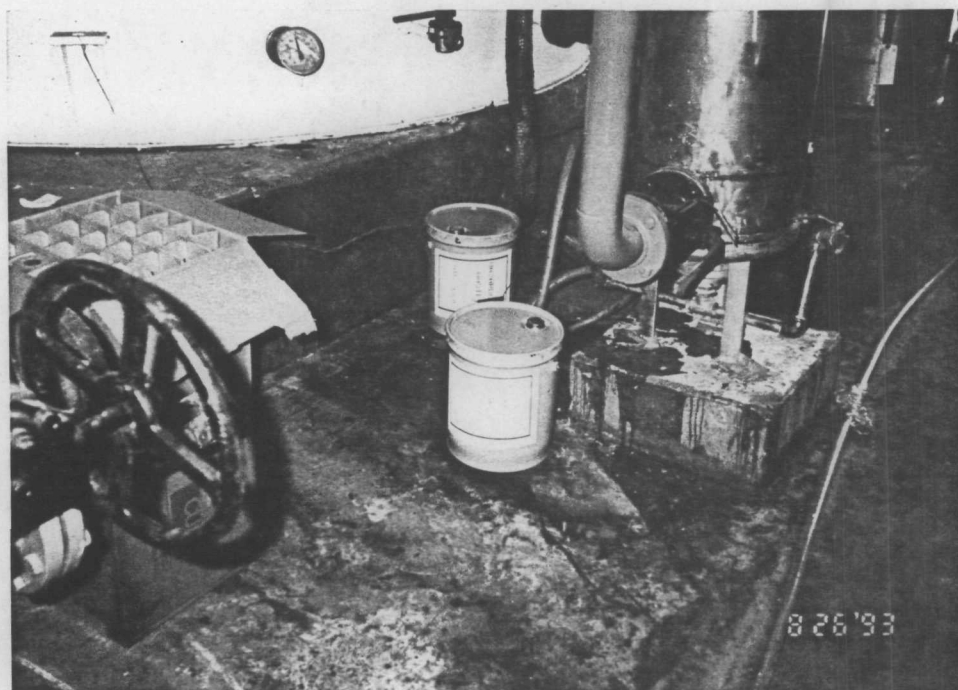
Photograph No. 2

Description: This photograph shows one of the waste polyacrylic solution (F003, D001) satellite accumulation units.

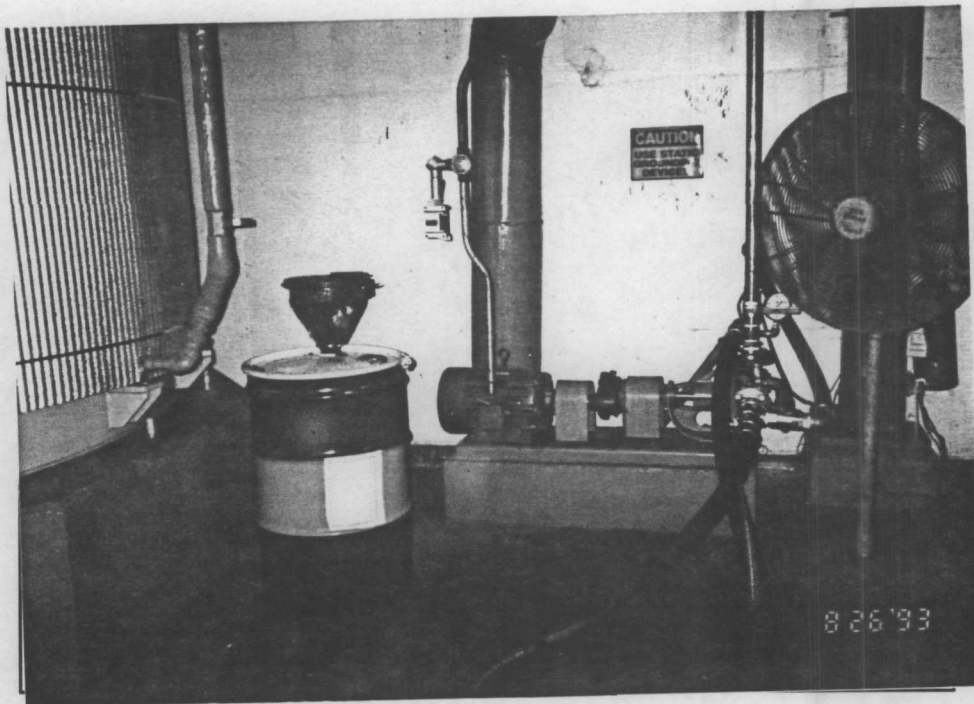
Photograph No. 3

Description: This photograph shows a 55-gallon drum in the lacquer department used to accumulate waste polyacrylic solution (F003, D001).

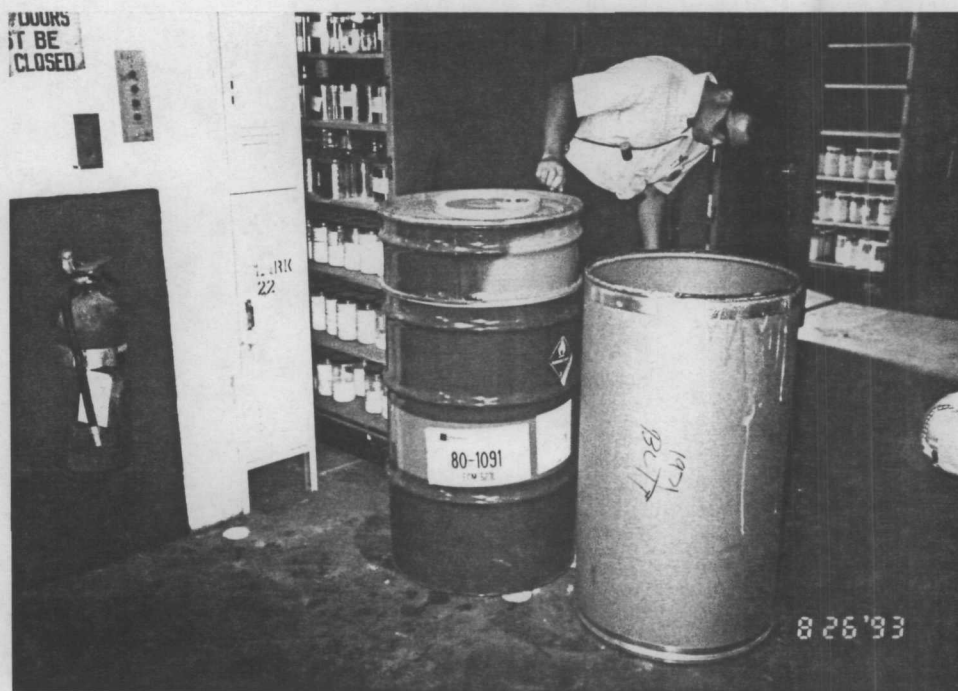
Photograph No. 4

Description: This photograph shows a 55-gallon drum near laboratory area used to accumulate waste polyacrylic solution (F003, D001).

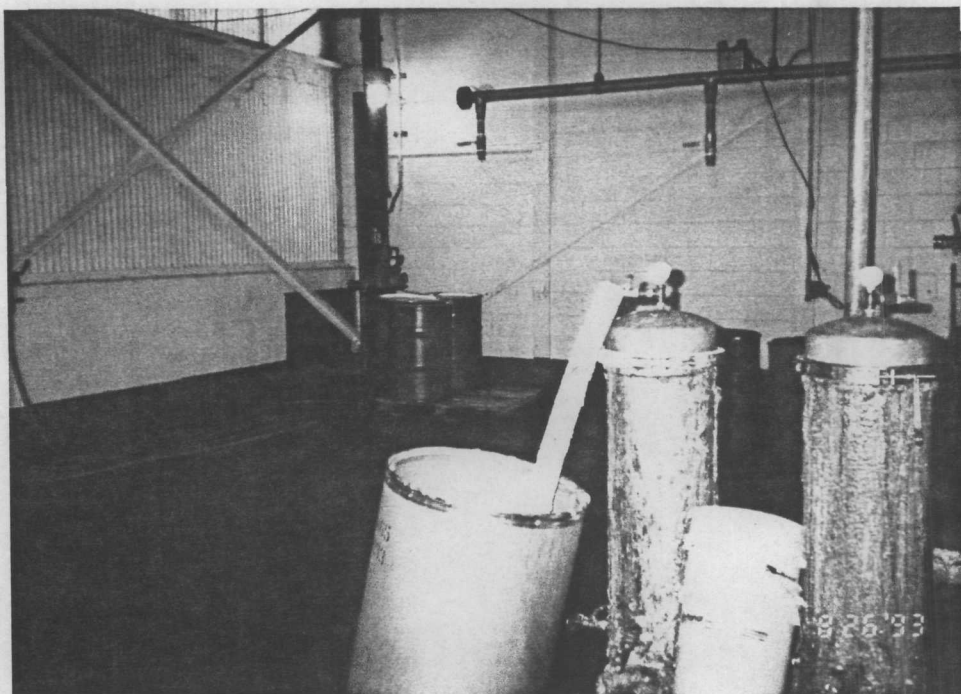
Photograph No. 5

Description: This photograph shows a 30-gallon cardboard drum in the lacquer department used for waste cylindrical cartridge filters (nonhazardous).

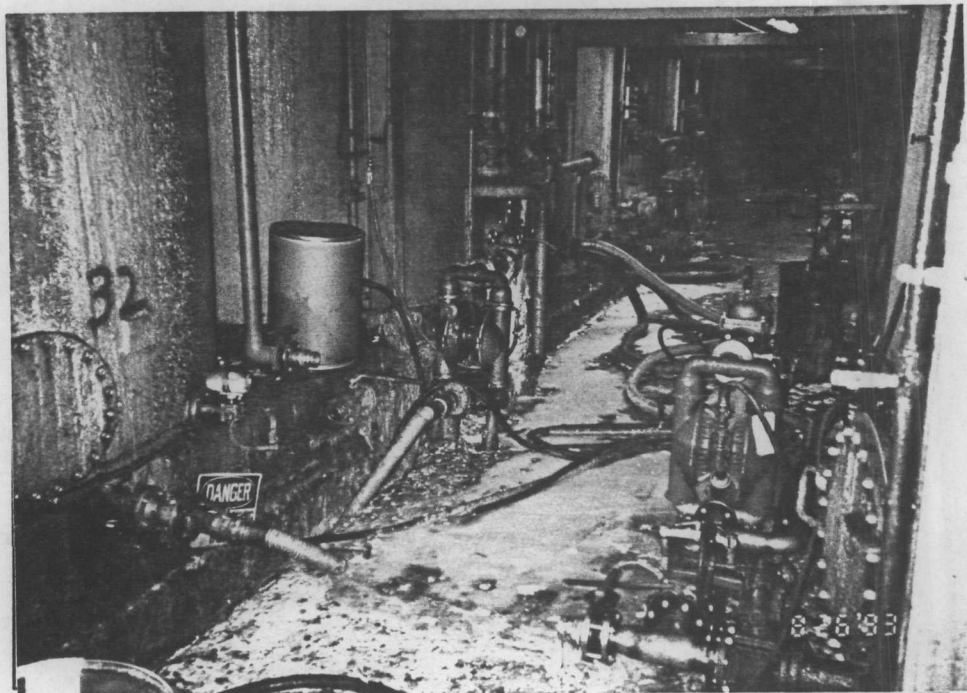
Photograph No. 6

Description: This photograph shows solidified waste resin (nonhazardous) spilled on the floors while being pumped out from the storage tanks. The spilled material is either collected in drums and disposed of as special waste, or washed into the drainage trenches for treatment in the On-Site Wastewater Pretreatment Plant (SWMU 6).

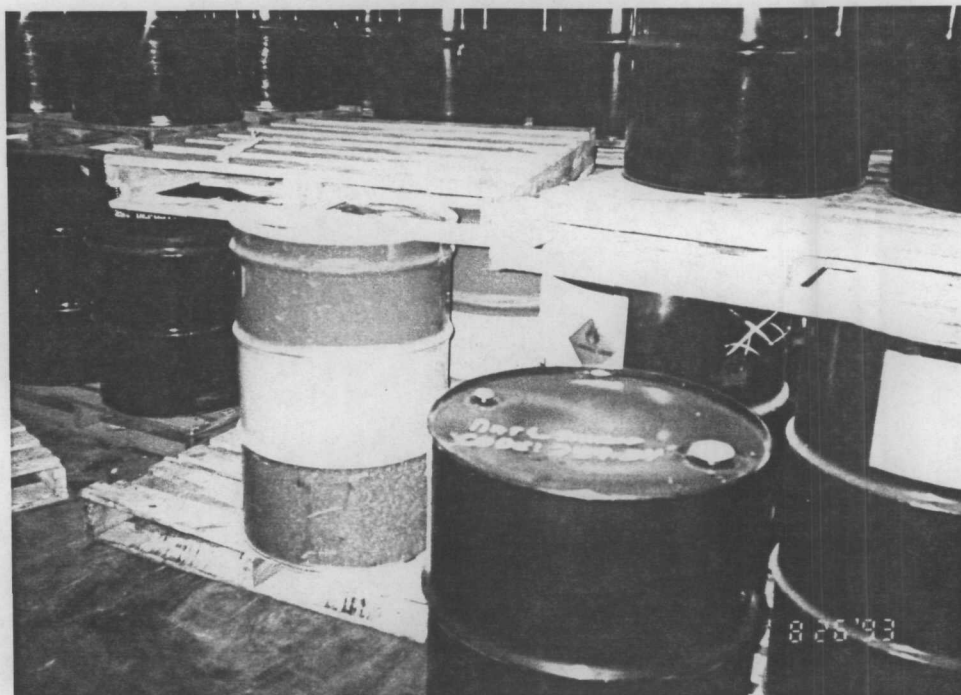
Photograph No. 7

Description: This photograph shows three 55-gallon drums of waste polyacrylic solution (F003, D001) in the Red Label Room Drum Storage Area. The black drums contain ignitable raw materials.

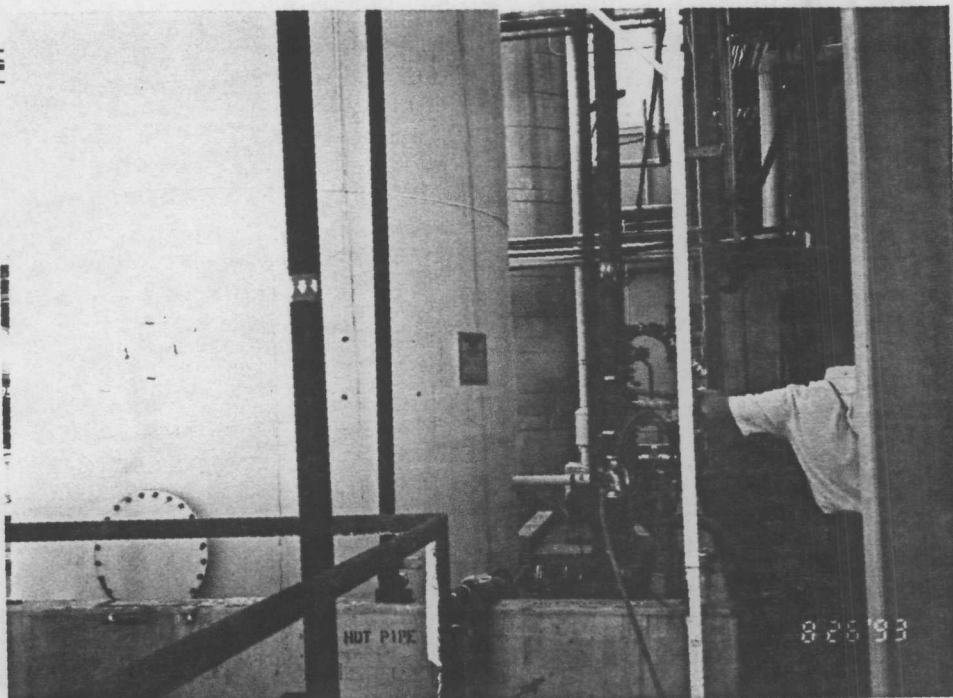
Photograph No. 9

Description: This photograph shows the two aboveground storage tanks (AST) that are part of the Solvent Storage Tank and Distillation-Extraction Columns. The AST in front is used to store spent isopropyl alcohol (IPA), ethanol and water (D001), while the one in the background is used to store the reclaimed IPA/ethanol mixture.

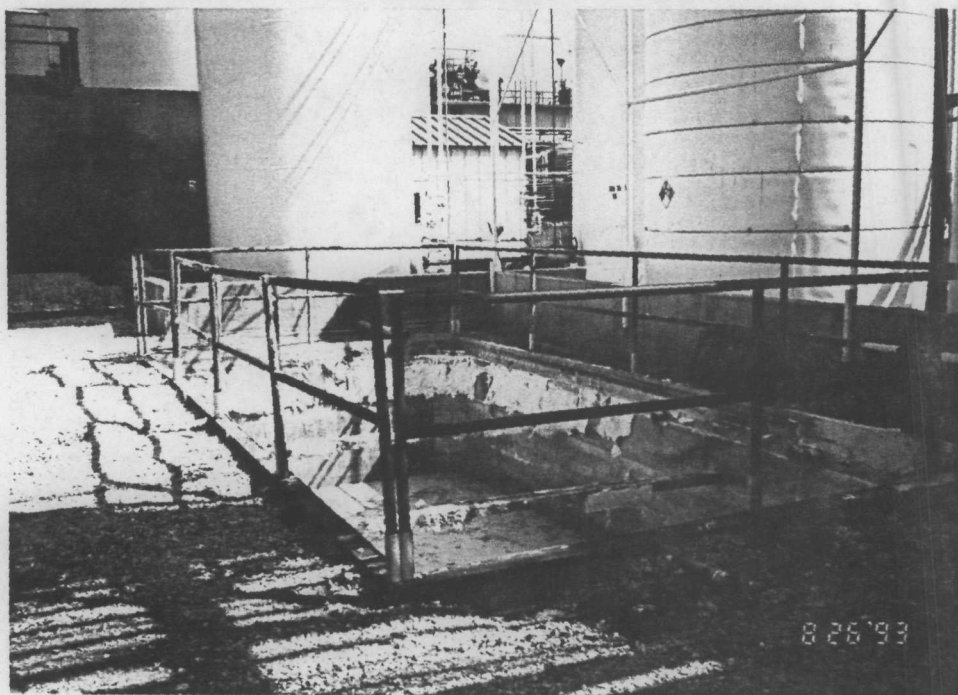
Photograph No. 10

Description: This photograph shows the steel pit that currently provides additional secondary containment for the ASTs that are part of SWMU 5.

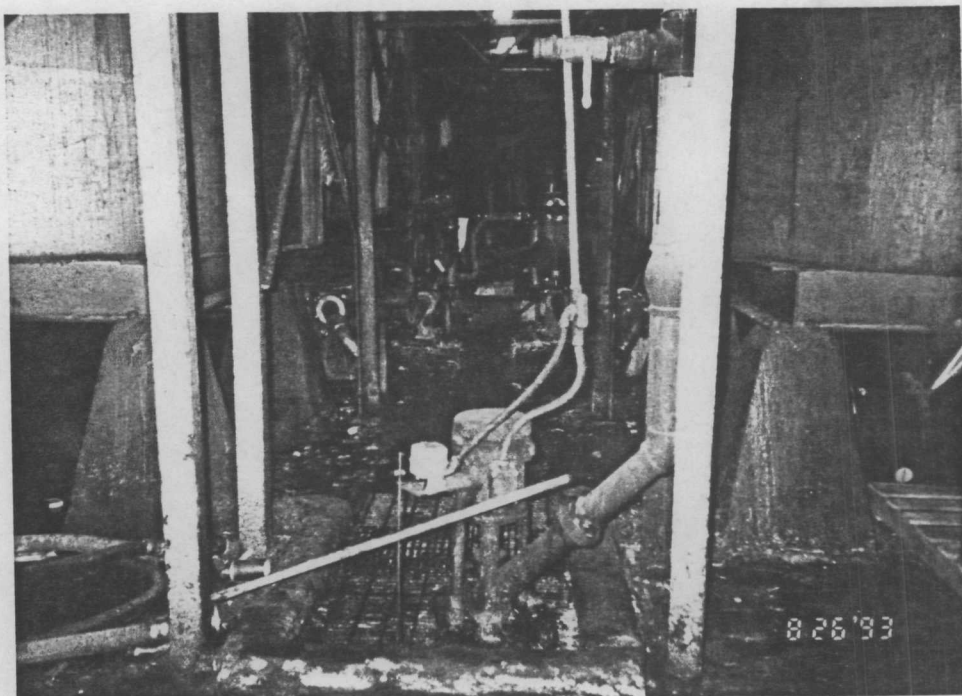
Photograph No. 11

Description: This photograph shows the area where all industrial wastewater from floor cleaning operations is discharged to the On-Site wastewater Pretreatment Plant (SWMU 6).

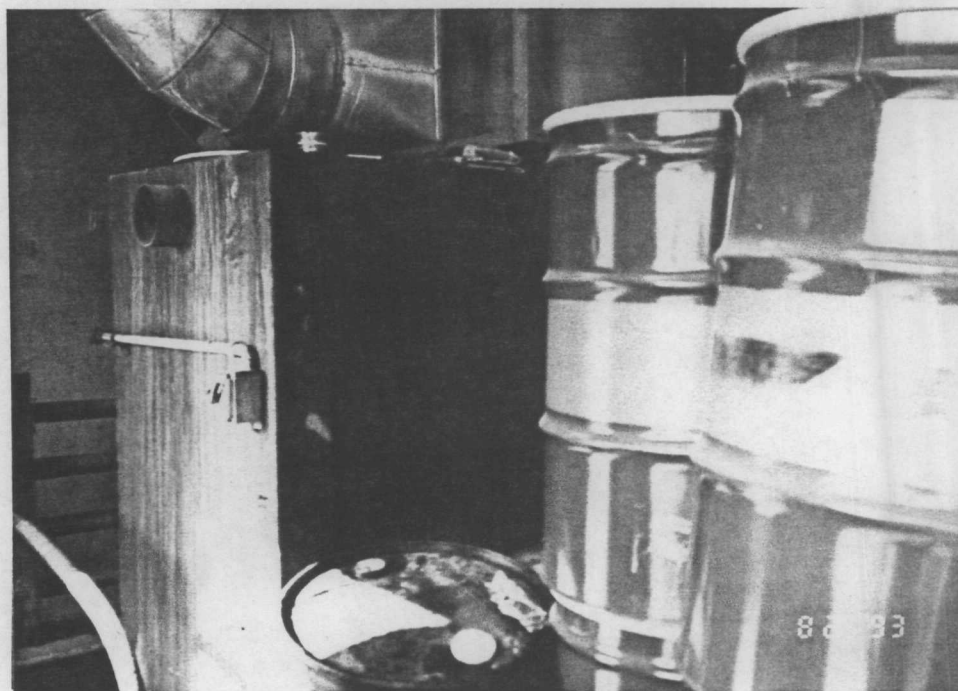
Photograph No. 12

Description: This photograph shows the steel hood where the empty drums of raw materials and wastes are cleaned. Wastewater from this unit is discharged directly to the On-Site Wastewater Pretreatment Plant (SWMU 6).

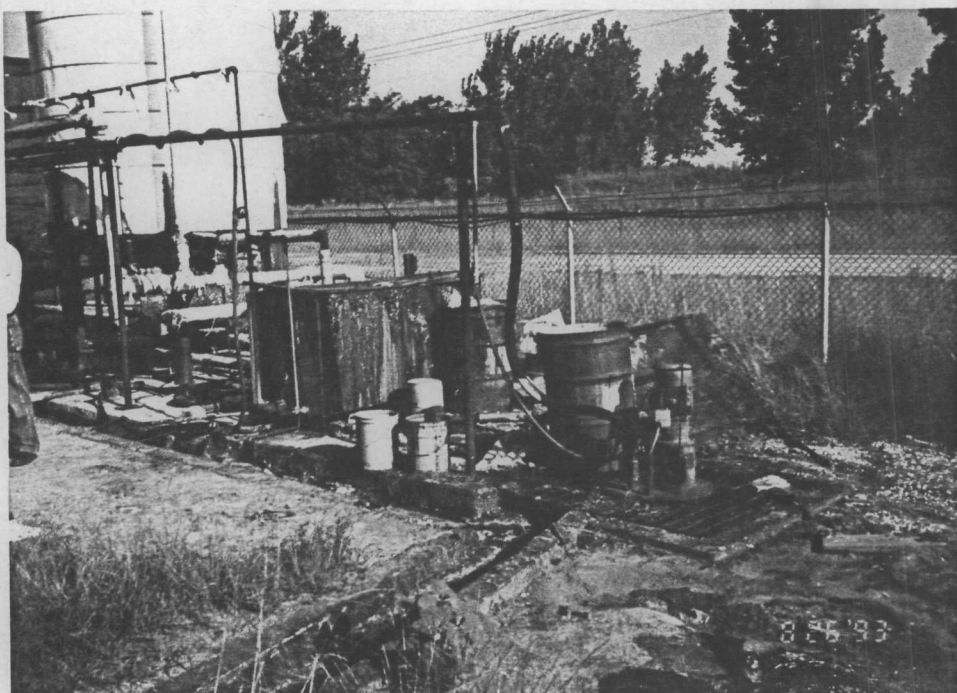
Photograph No. 13

Description: This photograph shows the steel bin in which the polyacrylic contaminated hoses are cleaned. Wastewater from this unit is directly discharged to the On-Site Wastewater Pretreatment Plant (SWMU 6).

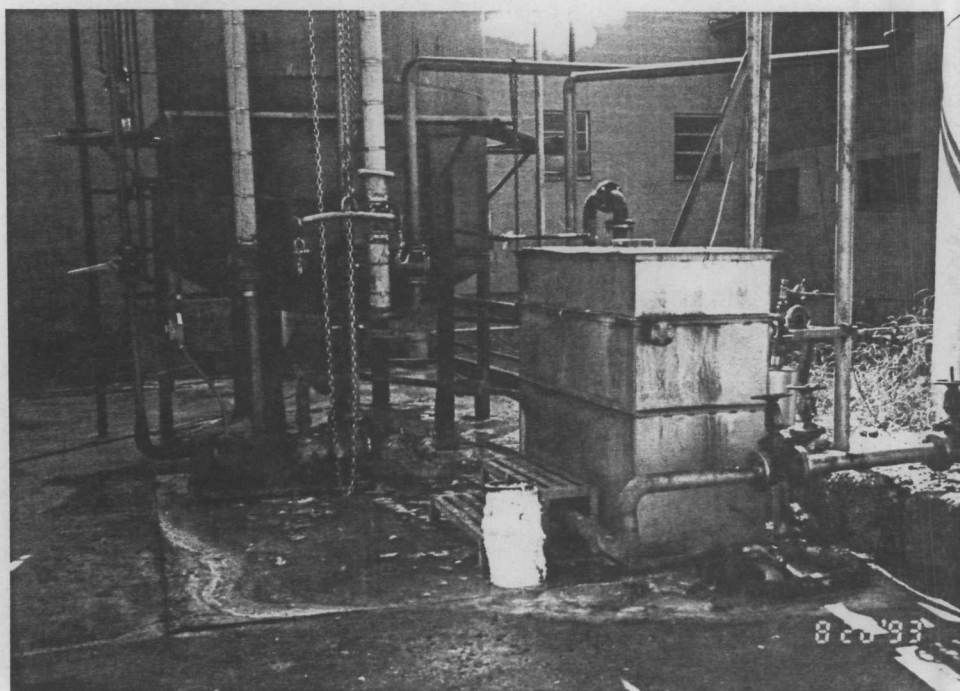
Photograph No. 14

Description: This photograph shows the steel bin used to clean the basket screens. A basket screen with emulsion solids (white) is adjacent to the bin.

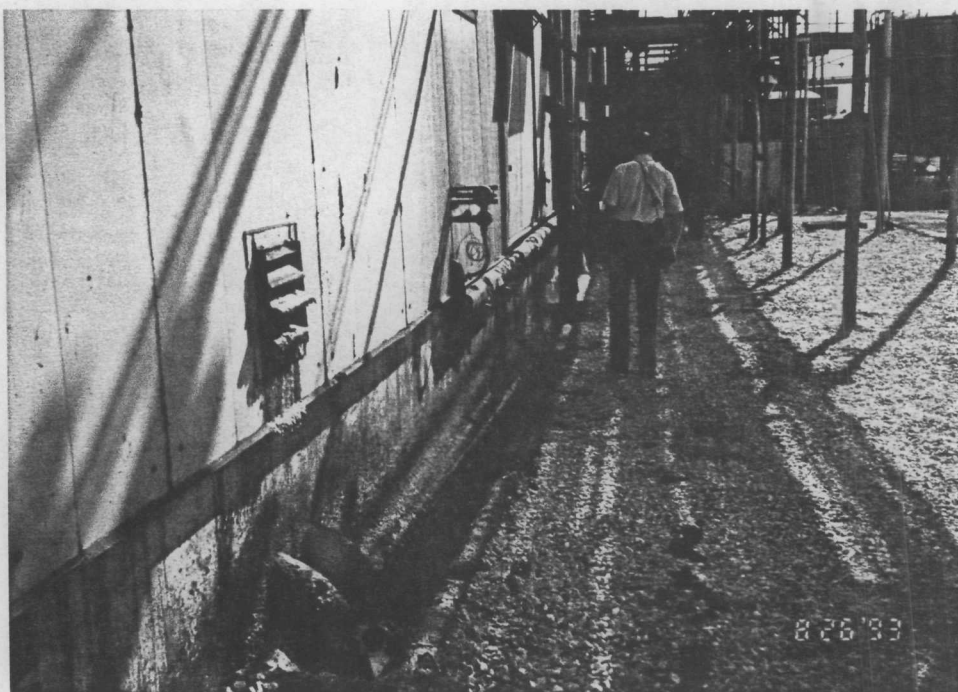
Photograph No. 15

Description: This photograph shows the drainage trench along one of the A-wing buildings that discharges to the On-Site Wastewater Pretreatment Plant (SWMU 6).

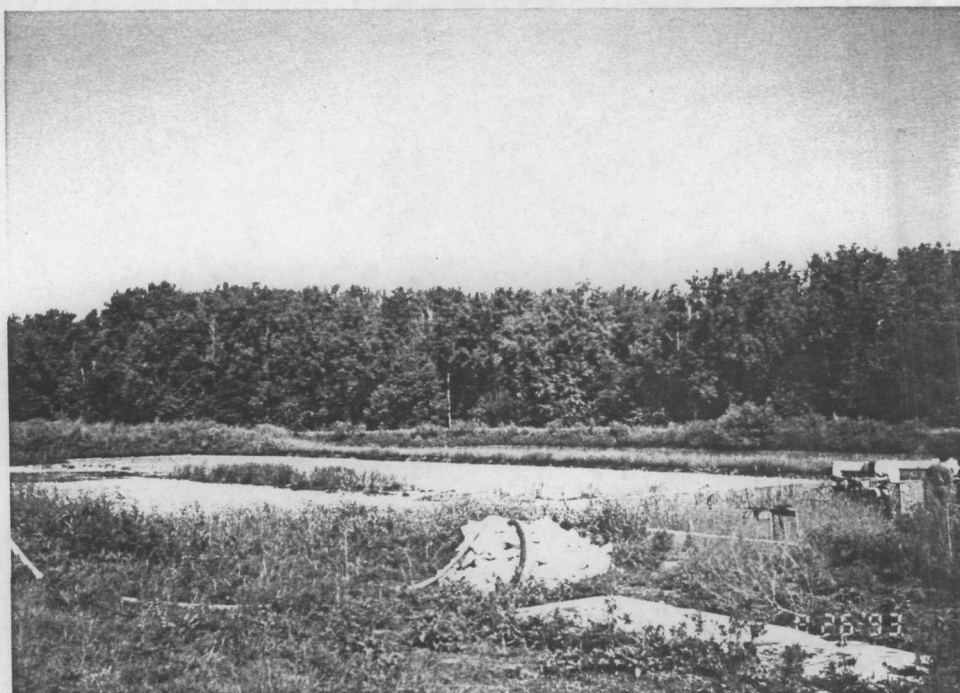
Photograph No. 16

Description: This photograph shows the grit settling basins that are part of the On-Site Wastewater Pretreatment Plant. Industrial wastewater throughout the facility is initially discharged to these basins before pretreatment.

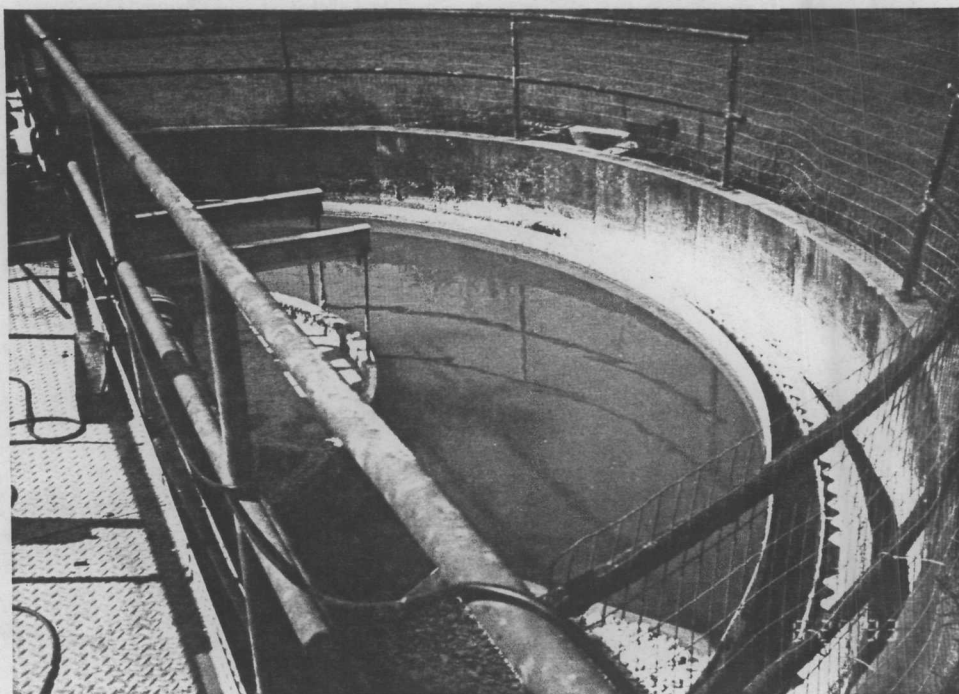
Photograph No. 17

Description: This photograph shows the primary clarifier in which chemical treatment occurs. Chemical sludge from this unit is pumped to the Chemical Sludge Lagoons (SWMU 12) for disposal.

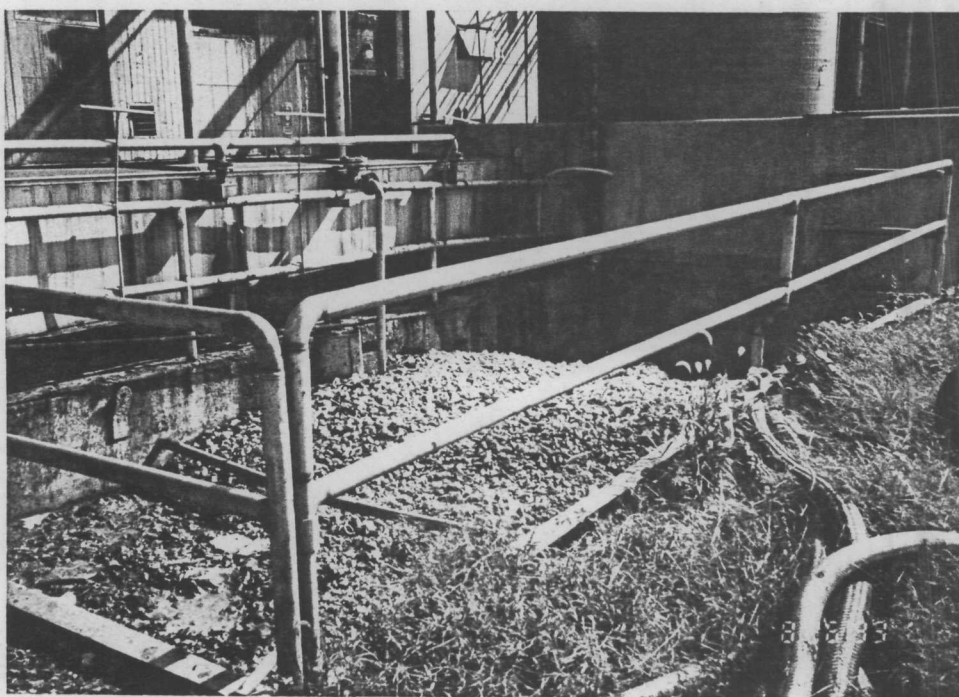
Photograph No. 18

Description: This photograph shows the A-Wing Neutralization Tank containing limestone. This tank is used to neutralize acidic waste solution.

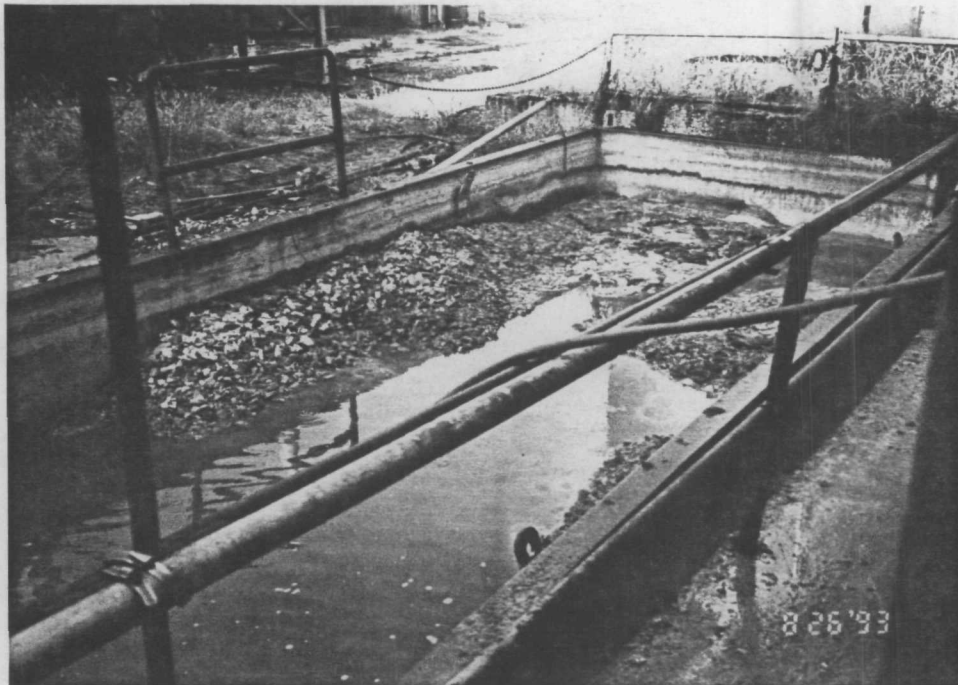
Photograph No. 19

Description: This photograph shows the B-Wing Neutralization Tank containing limestone. This tank is also used for neutralizing waste acidic solution.

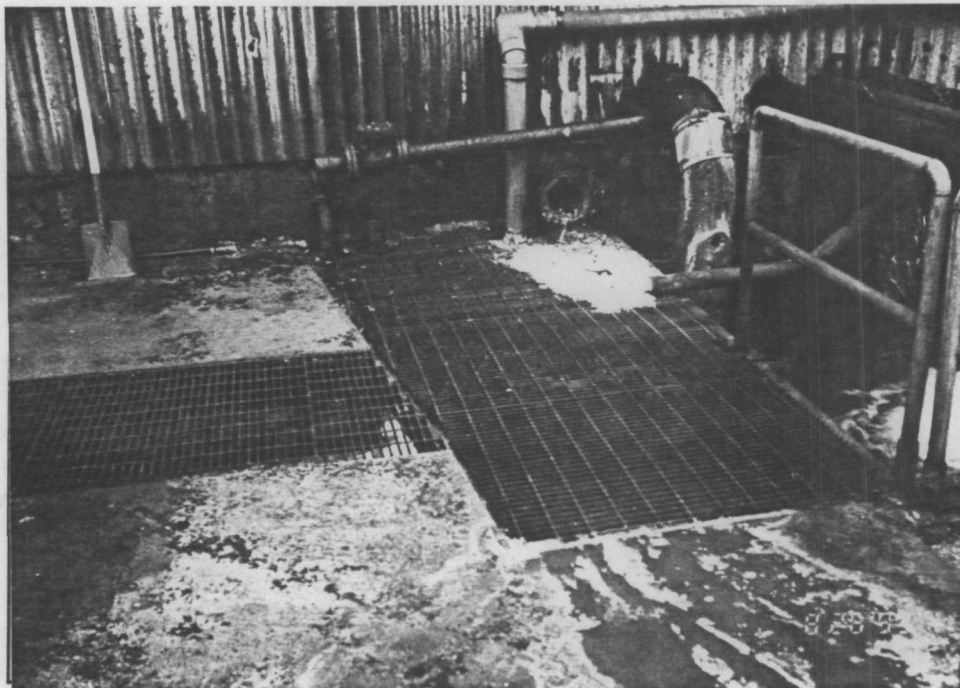
Photograph No. 20

Description: This photograph shows one of the Emulsion Wastewater Sumps (SWMU 8) located adjacent to Outfall 001C, used for noncontact cooling water discharges. Note the discharge pipe on top of the steel grate.

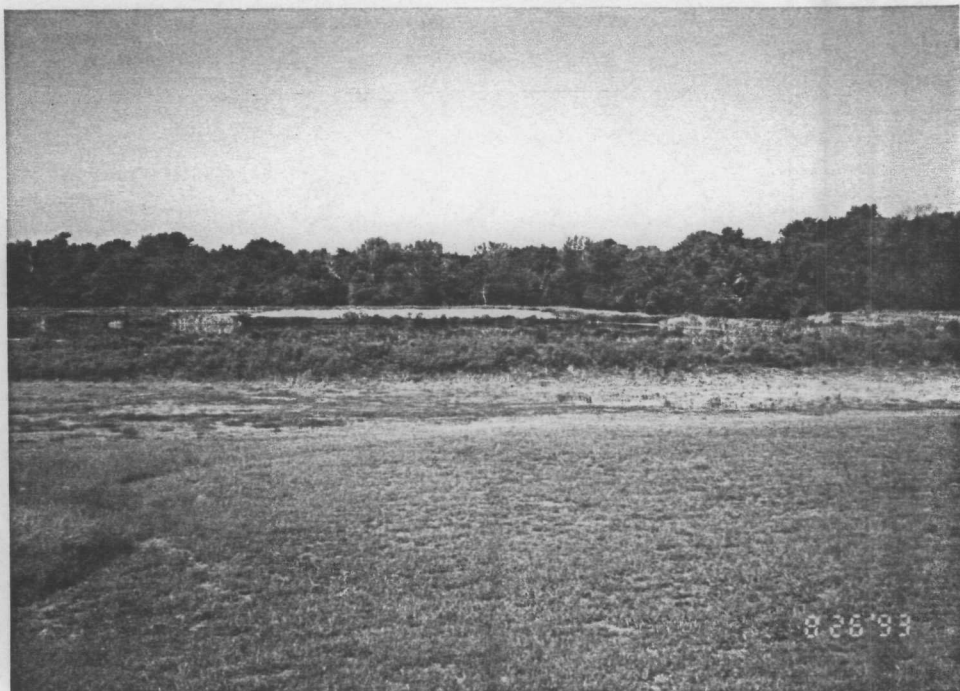
Photograph No. 23

Description: This photograph shows the general location of the Chemical Sludge Lagoons.

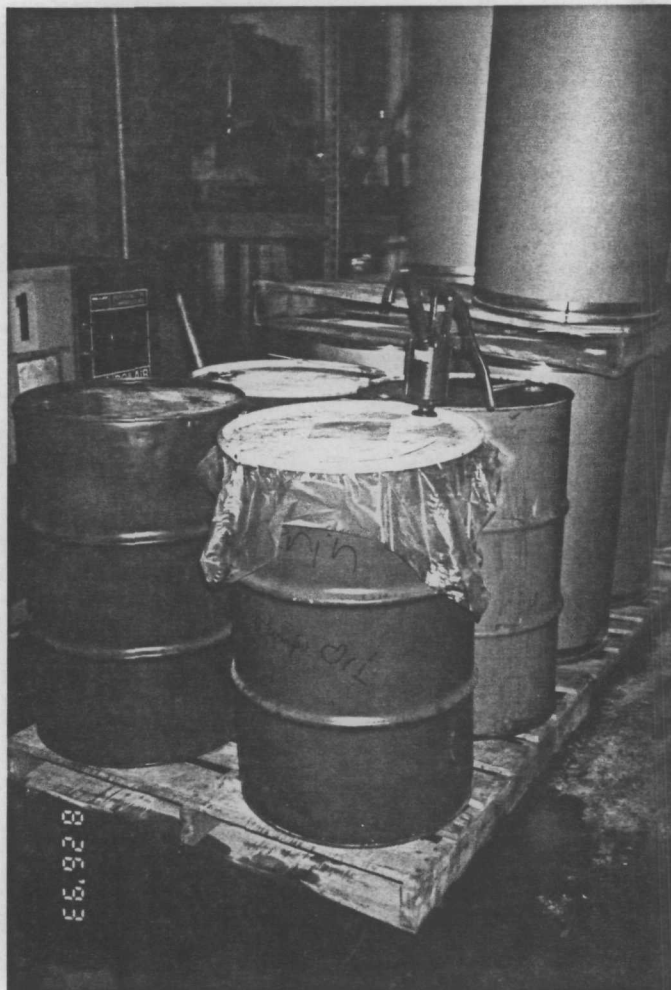
Photograph No. 24

Observations: During the VSI, PRC observed both storage areas. The storage area located outdoors contained 11 partly full to full drums labeled "used oil," and the one inside contained 4 full drums. Facility personnel could not positively identify the wastes stored in outdoor storage area. Apparently, these drums contained used oil (nonhazardous). PRC observed no evidence of release from this unit (see Photograph No. 24).
